BLACKSTONE RIVER BASIN  
MILLBURY, MASSACHUSETTS

DOROTHY POND DAM  
MA 00146

PHASE I INSPECTION REPORT  
NATIONAL DAM INSPECTION PROGRAM

JULY 1978

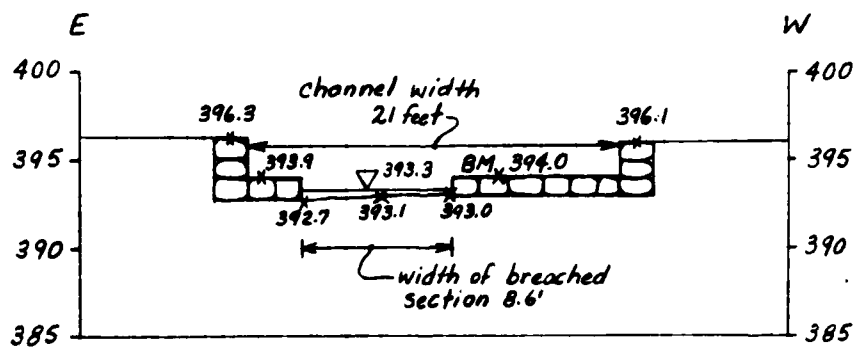
SPILLWAY SECTION 2-2

The spillway crest had been partially lowered 12 inches in 1955 (See Figure B-2) because of upstream flooding. This indicates that small changes in pond elevation could cause localized flooding to residences near the shoreline.

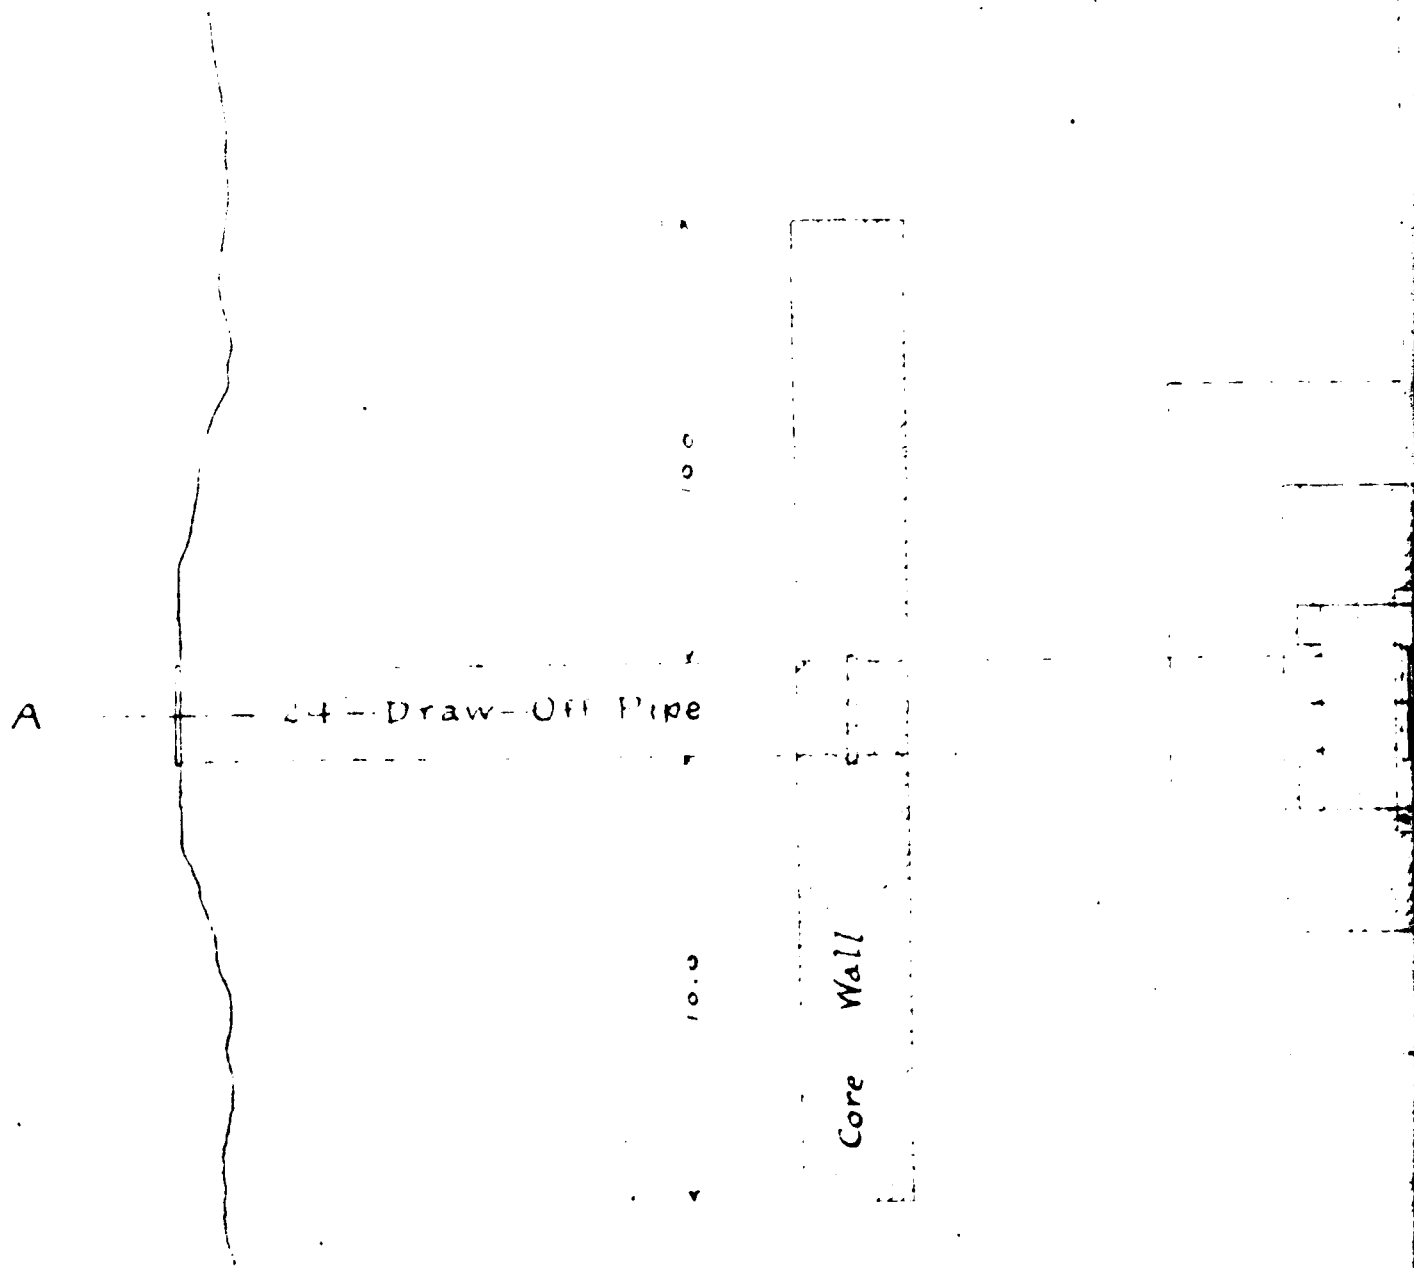
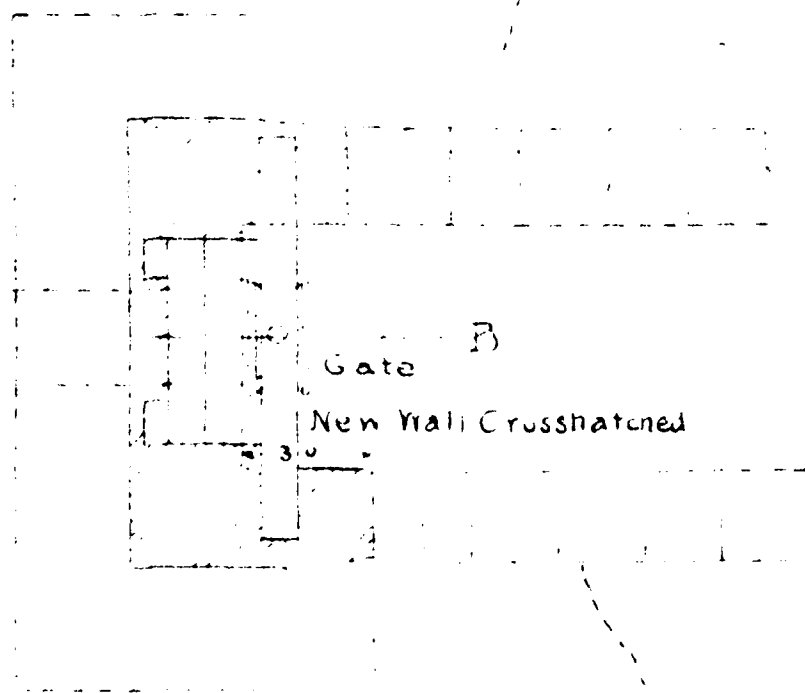
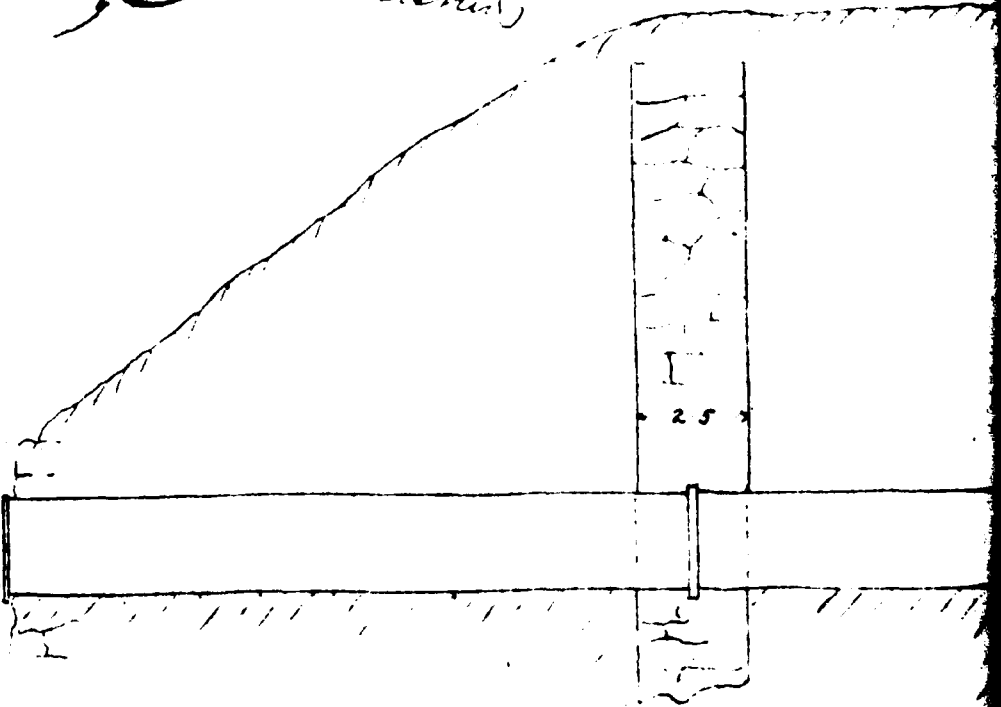
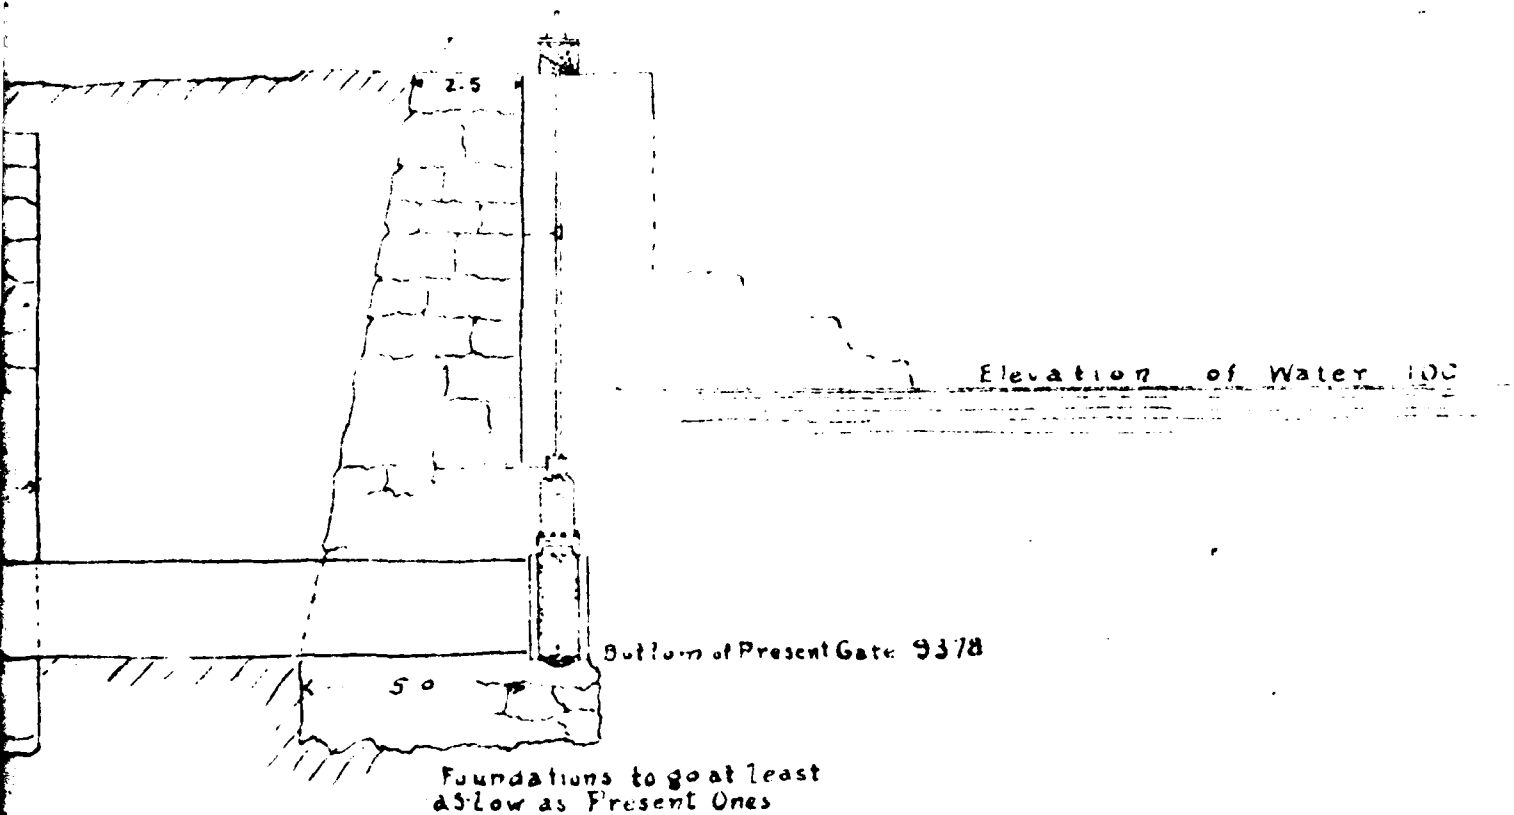
Planned Proposed Changes in Outlet

It was learned that this dam was built in 1825, probably of local soil or rock materials. As noted above, Figure B-3, shows a proposed stone masonry core wall. This core wall is shown to be 22-feet long by 14-feet high by 2.5-feet thick and is located 13 feet from the outlet conduit headwall. Since the dam is about 200 feet long, the core wall only extends for about 10 percent of the total length.
